Installation instructions Beach:

Rear pull-out for the VW T5-T6.1 California Beach and Multivan Loosen the VW Multiflexboad and then tip it off.

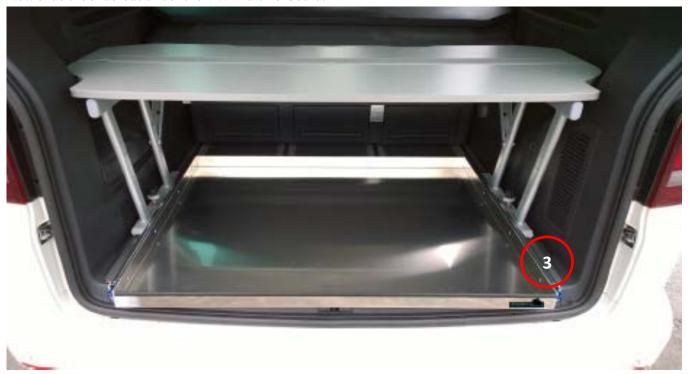
Now slide the slide-out under the VW Multiflexboard.
